Restoration Effectiveness In Cookhouse Meadow

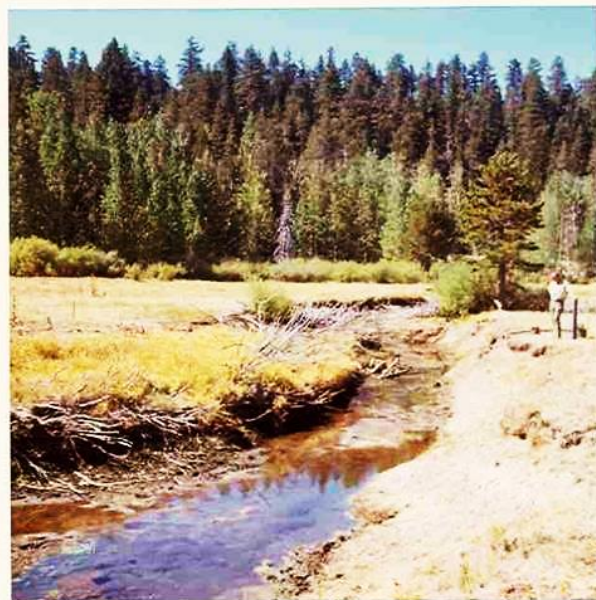
Big Meadow Creek in Cookhouse Meadow -1968

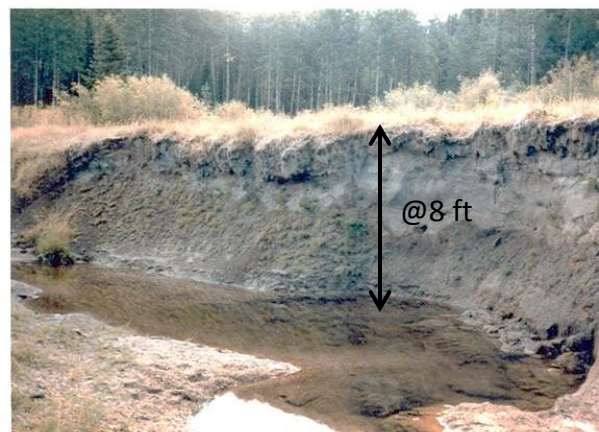
Big Meadow Creek in Cookhouse Meadow - 1981

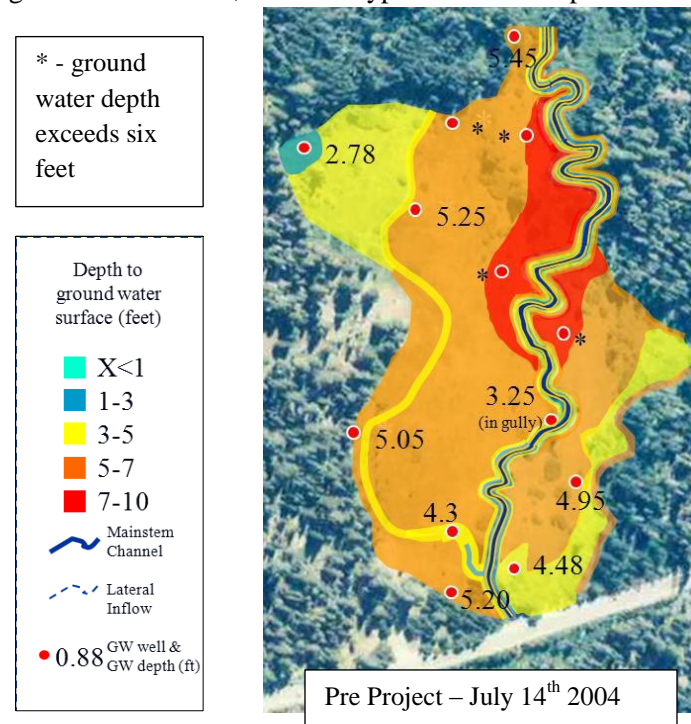
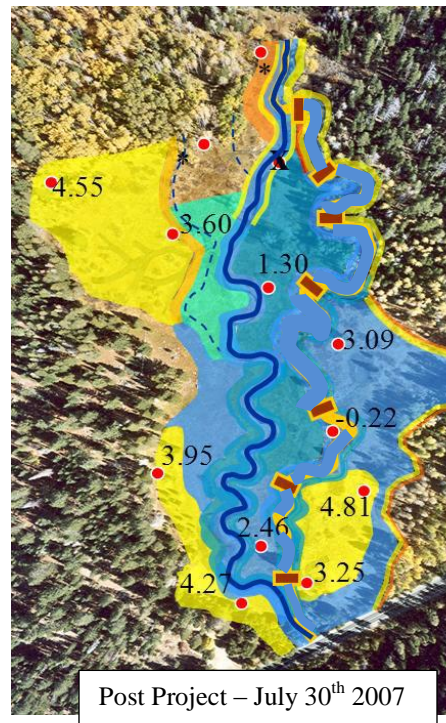
In addition, the restoration project has resulted in a 2 to 4 foot increase in groundwater levels, increasing the duration of available water for meadow vegetation substantially. Monitoring results indicate enhancement of both wet meadow flora and fauna as result.

between surface topography and groundwater pattern, coupled with groundwater depth measurements during the mid-summer period, for similar water year types (both below average with 2007 well below average). Photos and transect data indicate that riparian vegetation has responded favorably to these increased groundwater levels. Data on vegetation planted or salvaged as part of the project (sod harvesting, willow staking, willow mats) indicated a high success rate (approximately 90% survival). This is partially due to initial irrigation efforts during the dry season, as well as changes in groundwater and surface water hydrology.

The images below illustrate mapped pre and post project groundwater levels, based on typical relationships

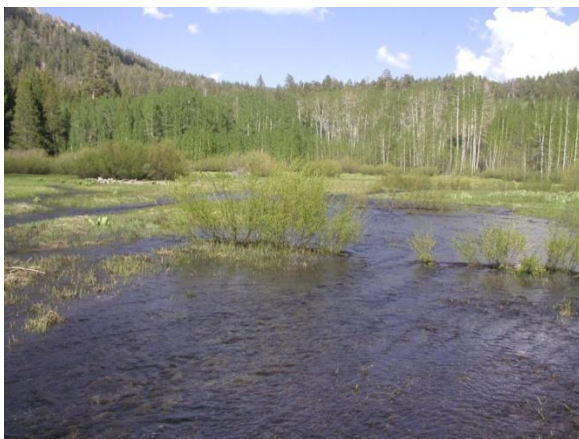
years. Some degree of over bank flooding has occurred nearly every spring post construction, and during the record water year of 2011, up to 3.8 acres of the meadow was flooded for approximately 70 days during spring runoff. Based on analysis of data collected after spring runoff, approximately 24 tons of fine particles (silt/clay) were deposited in the floodplain.

Flooded Meadow during June - 2011

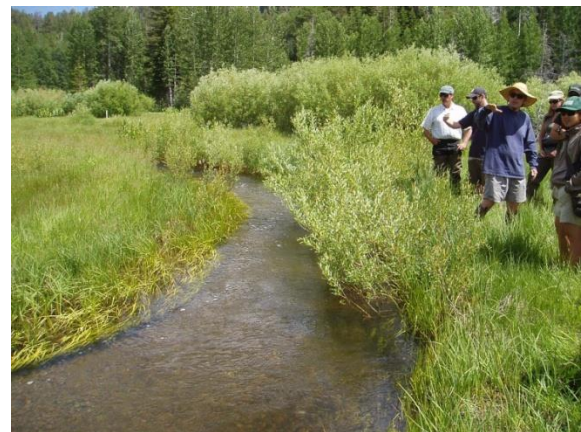
Meadow and Channel Riparian Vegetation – July 2011
